The route to successful repair & maintenance

for external wall insulation

Overview of project at St. Helens College - repairs to EWI system to spine wall.

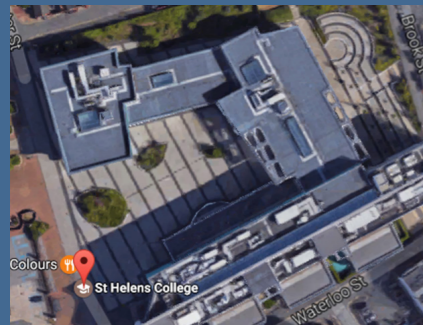
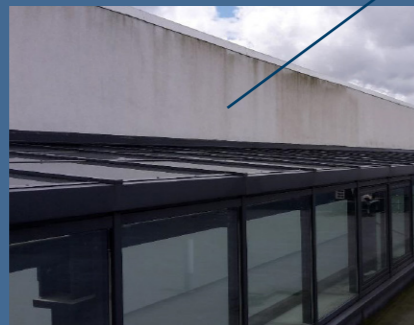
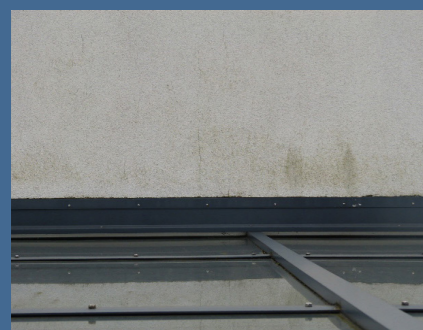
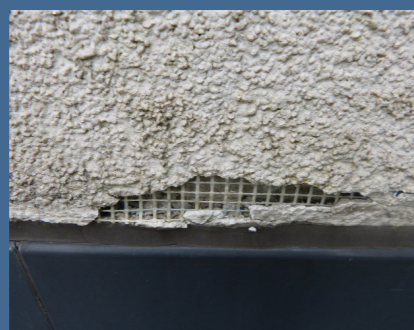
St. Helen's College

Detrition of spine wall above atrium glazing

The point of failure

The nature of failiure

- o The working platform needed a bespoke cantilever design due to works being over a glazed atrium;
- o Movement and storage of materials during the works were limited to defined points...
- o Due to plant and flat roof construction, the walkways were susceptible to damage and required a specific access and egress plan.

Specification of works i.e. SERS and the manufacturer worked closely to produce a method statement for the EWI repairs to ensure that the system warranty was unaffected by the damage or the remedial works.
